NASA TECHNICAL
MEMORANDUM

June 1974

NASA TM X-64821

MSFC SKYLAB APOLLO TELESCOPE MOUNT EXPERIMENT
SYSTEMS MISSION EVALUATION

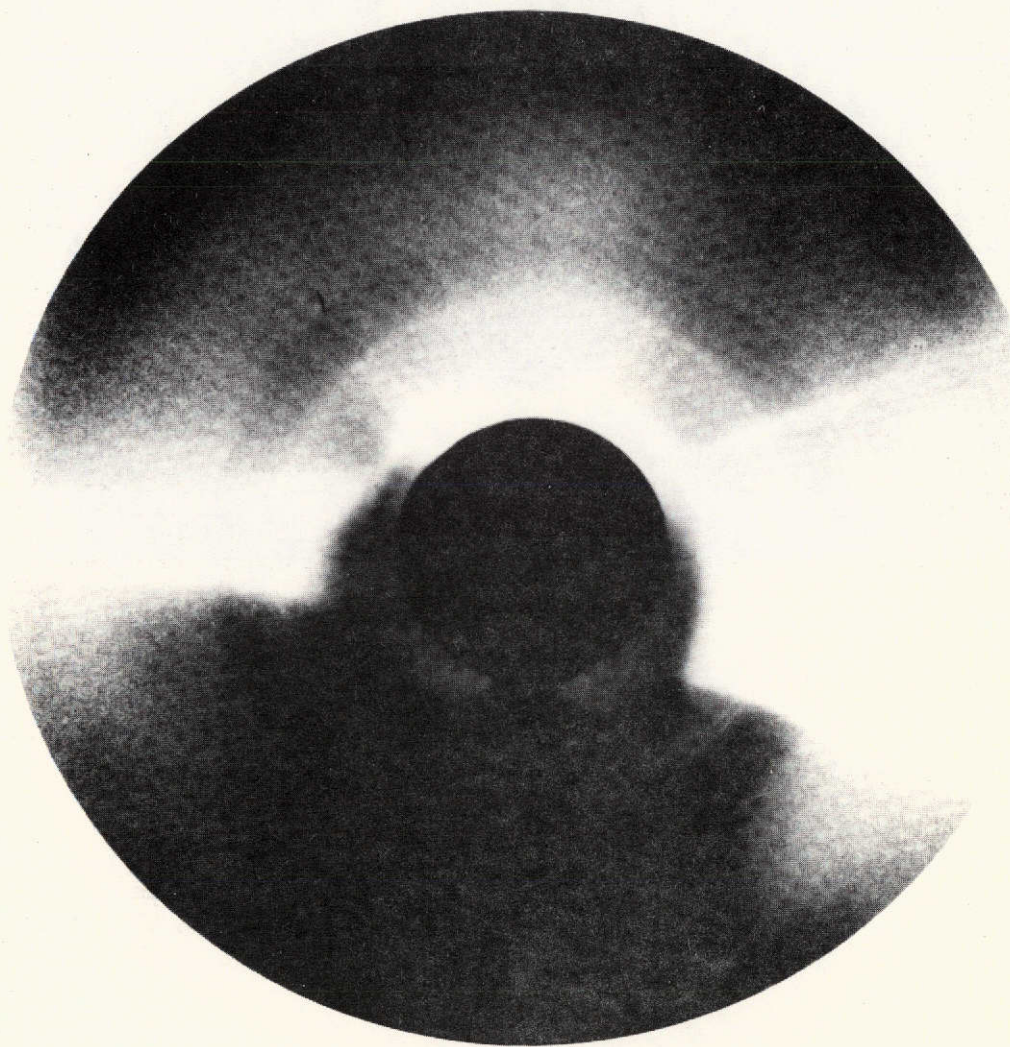
FIGURE 16. S052 FILM CAMERA PHOTOGRAPH OF COMET KOHOUTEK

Figure 16 shows Comet Kohoutek when it was 14.6 million miles from the Sun and 106 million miles from Earth. At this time the Comet was behind the Sun moving toward the left (ahead of the tail) and was approximately 28 hours from its nearest approach to the Sun (13 million miles).

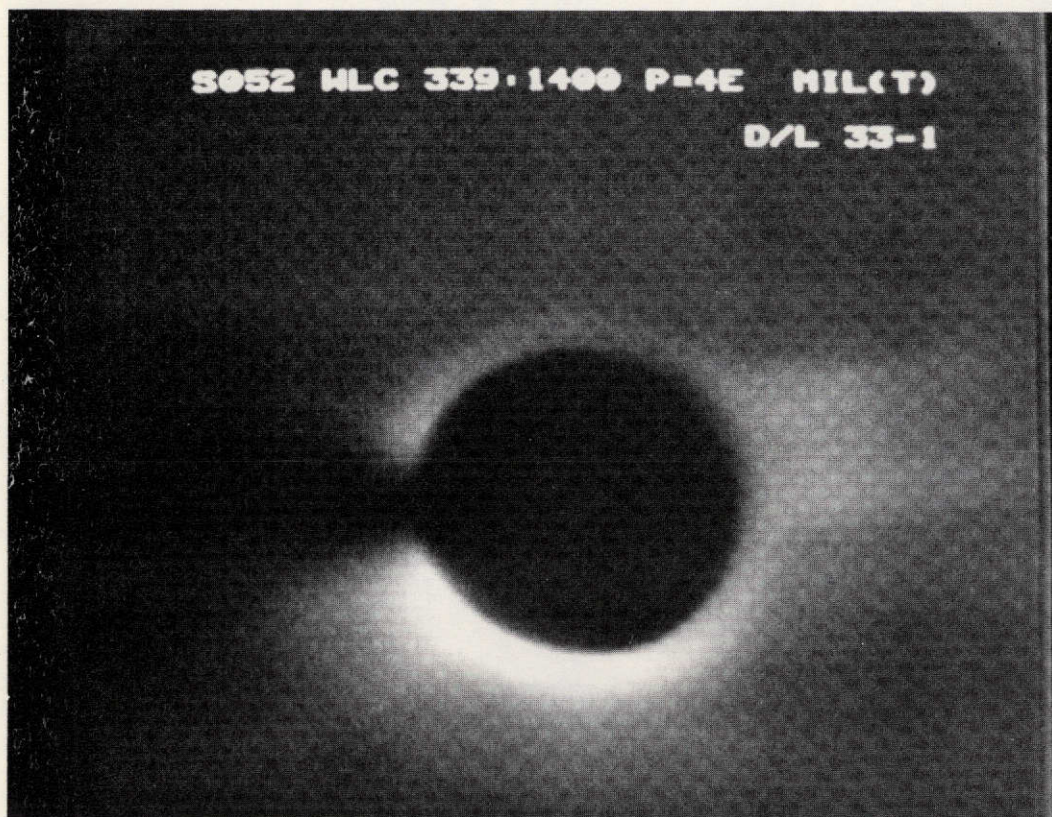
FIGURE 17. S052 TV MONITOR DISPLAY RECORDED FROM TV DOWNLINK

Figure 17 presents a typical TV monitor display, as recorded from TV downlink. The occulting disk supporting leg (pylon) was at the left of the picture, so that the orientation of the S052 pictures on the TV monitor was consistent with the other instruments. The TV display proved useful to the crew and to the scientists on the ground: coronal features were visible, enhancing the definition of the observing program; the TV was used to calibrate S052 Sun-center pointing with respect to the PES; contamination on the front occulting disk was twice observed on the TV which permitted early corrective action by a crewman during EVA.

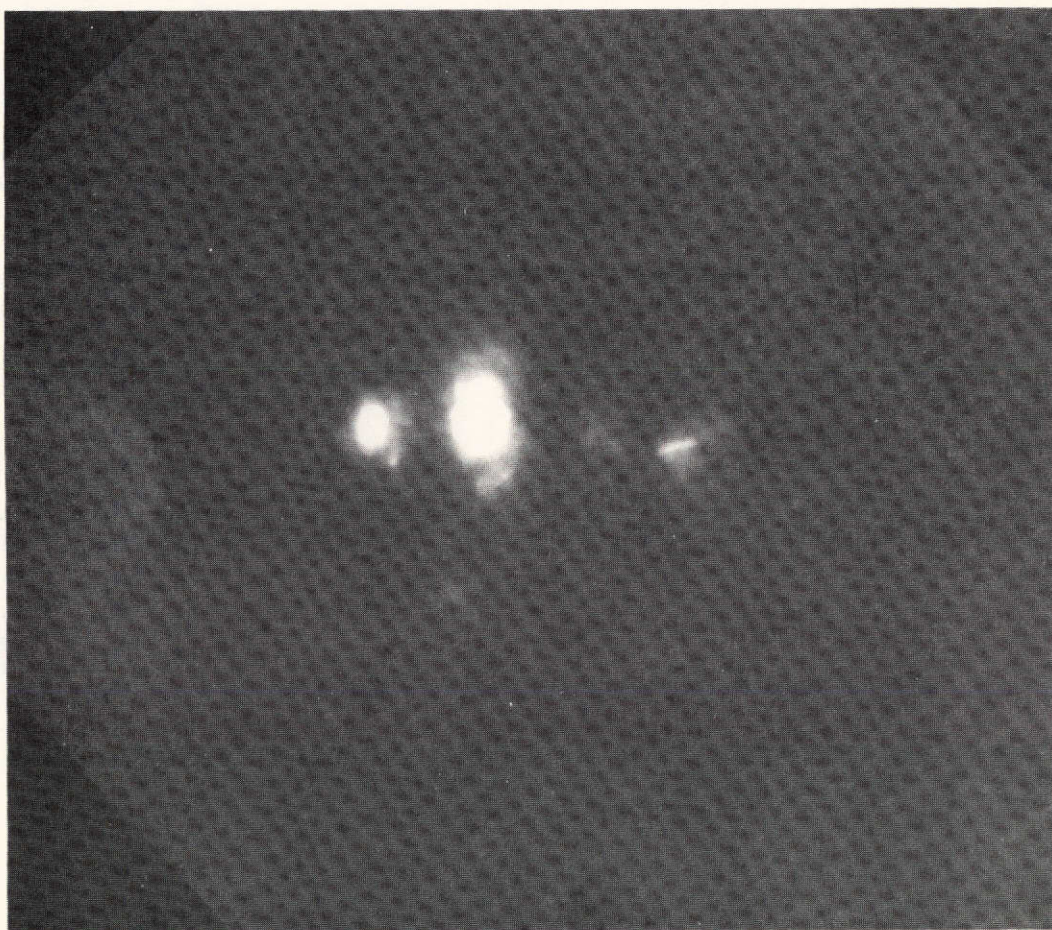
FIGURE 37. S054 SOLAR IMAGE THROUGH FILTER 5

Filter Wheel Failure. On DOY 331 during initial checkout of the ATM systems for Skylab 4 manned operations, the filter wheel stopped between filters 5 and 6. Filter 5 is a 2-mil beryllium filter; filter 6 is a 1-mil beryllium filter. Since these were the most dense filters in the filter wheel, data taken from DOY 331 until the EVA repair on DOY 359, were limited to features with relatively high surface brightness. Flares, active regions, and coronal bright points typically have high surface brightness. The S054 photograph shown in figure 37 illustrates the field-of-view with reduced intensity resulting from the filter wheel being

stuck between positions 5 and 6. Simulation tests verified that it was possible for the crew to move the filter during EVA. EVA procedures were developed for this purpose, and on DOY 359 the EVA filter repair was attempted. The procedure involved manually opening the shutter, and moving the filter wheel with a modified existing tool. During the EVA, the shutter was bent out of its guides making it impossible to operate the shutter. The shutter opening was cleared by bending the shutter out of the way. The filter wheel was subsequently moved to position 3 (no filter).

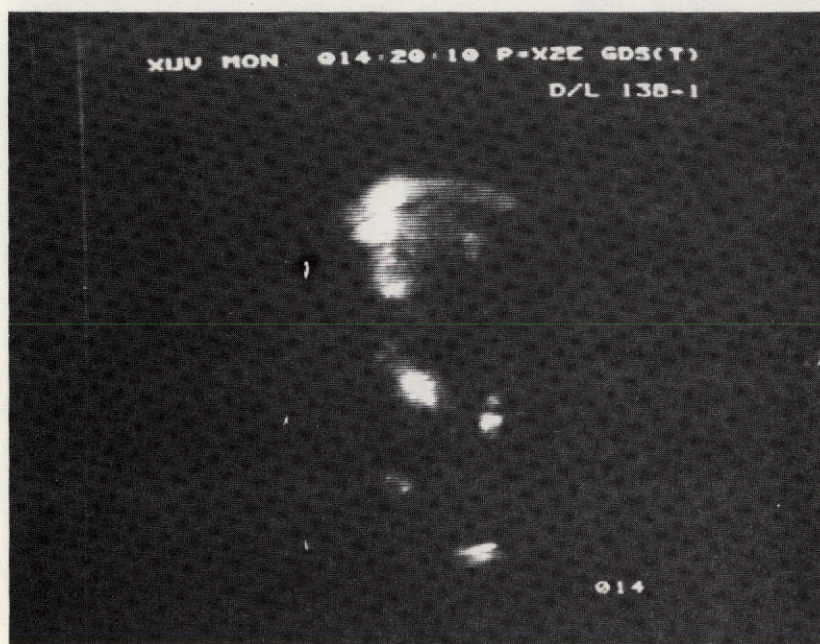
FIGURE 63. S082B XUV MONITOR 1-SECOND INTEGRATION

Figures 63 through 65 illustrate examples of XUV Monitor data. The photographs show a comparison between Skylab 2 and Skylab 4 data. The integration times were approximately 1, 2, and 4 seconds as shown in figures 63, 64, and 65, respectively.

Figures 63 through 65 illustrate examples of XUV Monitor data. The photographs show a comparison between Skylab 2 and Skylab 4 data. The integration times were approximately 1, 2, and 4 seconds as shown in figures 63, 64, and 65, respectively.
